**Research Article**

## **VULNERABILITY ANALYSIS OF EMBANKMENT BREACHING – A CASE STUDY OF MOYNA DRAINAGE BASIN IN PURBA MEDINIPUR WEST BENGAL INDIA**

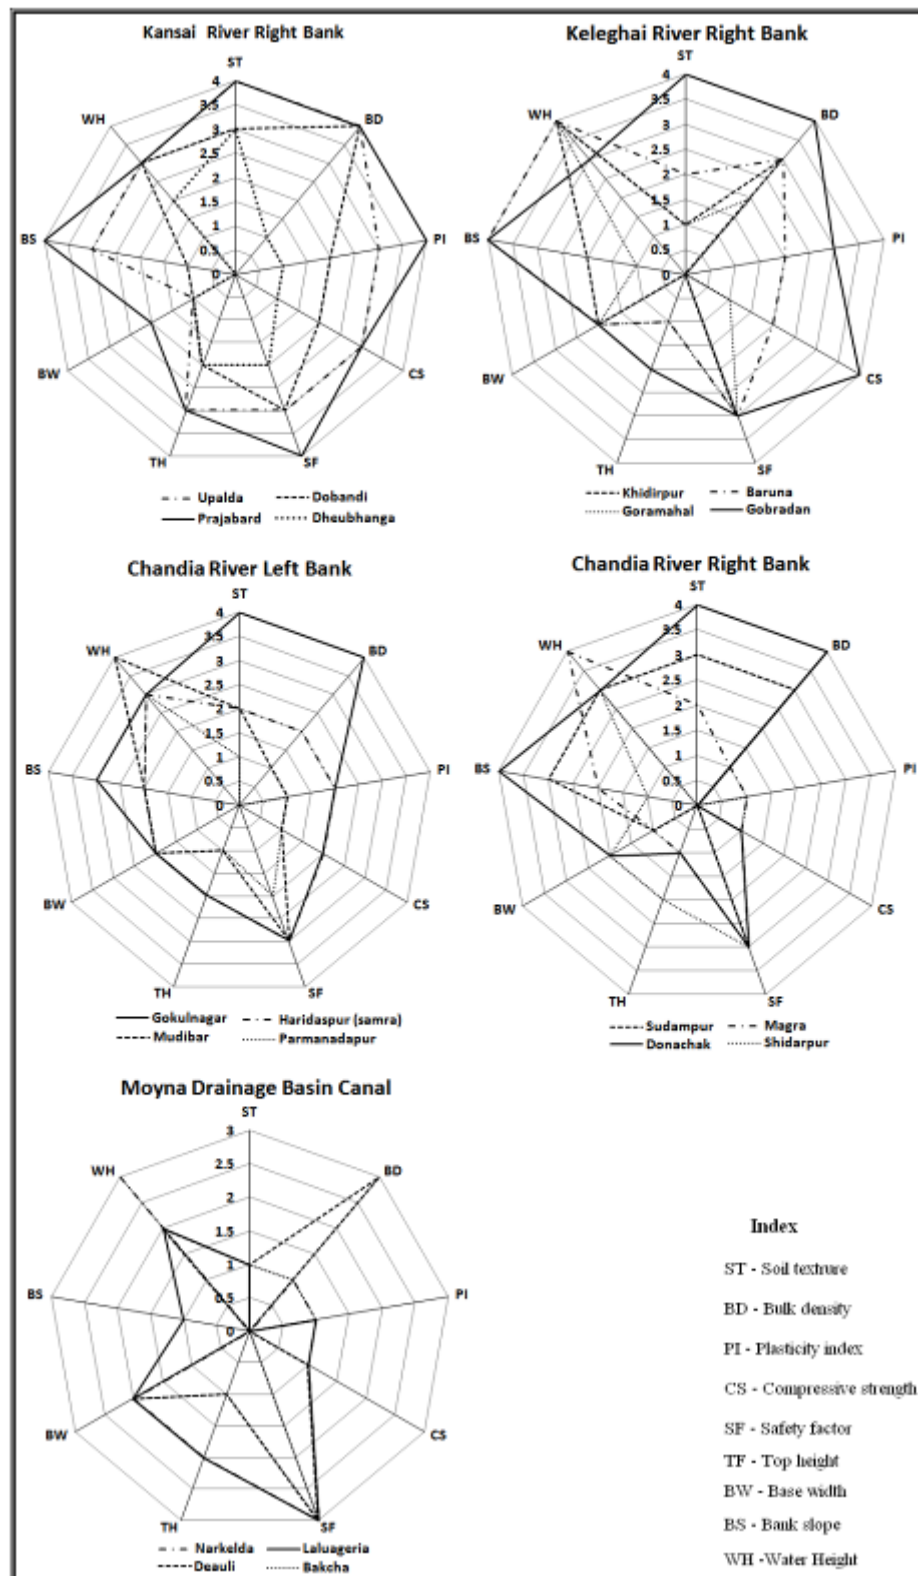
**Figure 4: Amoeba Diagrams indicating the River Embankment Breaching Vulnerability Index (REBVI) of Moyna Drainage Basin Area**

Moyna drainage basin area is bounded by five embankments viz. Kasai river right bank, Chandia river left bank, Chandia river right bank, Keleghai right bank and Moyna drainage basin Canal (Figure 1). The river embankment breaching vulnerability index (REBVI) of these five embankment regions were represented in amoeba diagrams (Figure 4). The result of the amoeba diagram analysis showed Kasai river right bank embankments occupied maximum area than other embankment of this drainage basin. Keleghai right bank embankment is occupied as second position of vulnerable point for embankment breaching. In this embankment region, the calculated value of REBVI at Gobradan and Baruna was maximum, e.g. 73 and 58 respectively.

In general, breaching is observed at the deeper concave bank of the meandering course. The constants need for adjustment of gradient with load necessitates the shift of thalweg point and thus the embankment breaching prone areas are also changing. Overtopping is the most destructive mechanism, observed during rainy monsoon season in the drainage basin area. The river flow becomes supercritical on the opposite side of embankment and thus erosion starts on that side. Additionally, the embankment may obliterate for meters together by this process.

according to vulnerability index of embankment breach. Cluster-I (<40 REBVI value) and II (REBVI value of 41 - 50) represents very low vulnerability point at Narkelda, Deauli, Khidirpur Lualageria, Bakcha, Magra, Goramahal, Dheubhanga, Shidarpur, Parmanadapur, Sudampur, Mudibar, and Haridaspur (Samra). In this area the consistence of the embankment is very high. Cluster III (REBVI value of 51 – 60) represents moderate vulnerability point at Dobandi, Gokulnagar, Donachak, Baruna. In Cluster IV (REBVI value of 61 – 70) and V (>70 REBVI value) very high vulnerability points were delineated at Prajabard, Gobradan and Upalda, showed less potential to prevent embankment breaching by the fluvial hydraulic action and rainy storm.
