Research Article

HUMAN INDUCED BANK FAILURES ALONG THE LOWER BALASON RIVER IN DARJEELING DISTRICT, WEST BENGAL

Key Words: *Bank Failures, Bed Material Extraction, Human Occupancy*

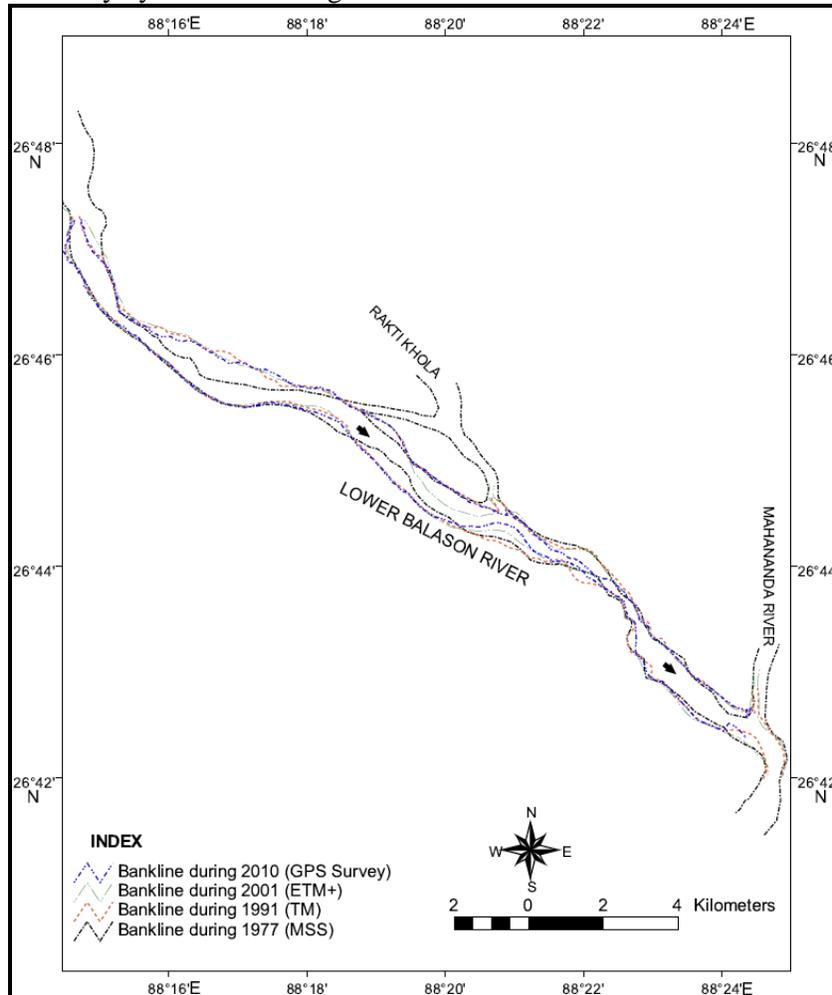
Figure 2: The changes in bank line along the lower Balason River from 1977 to 2010

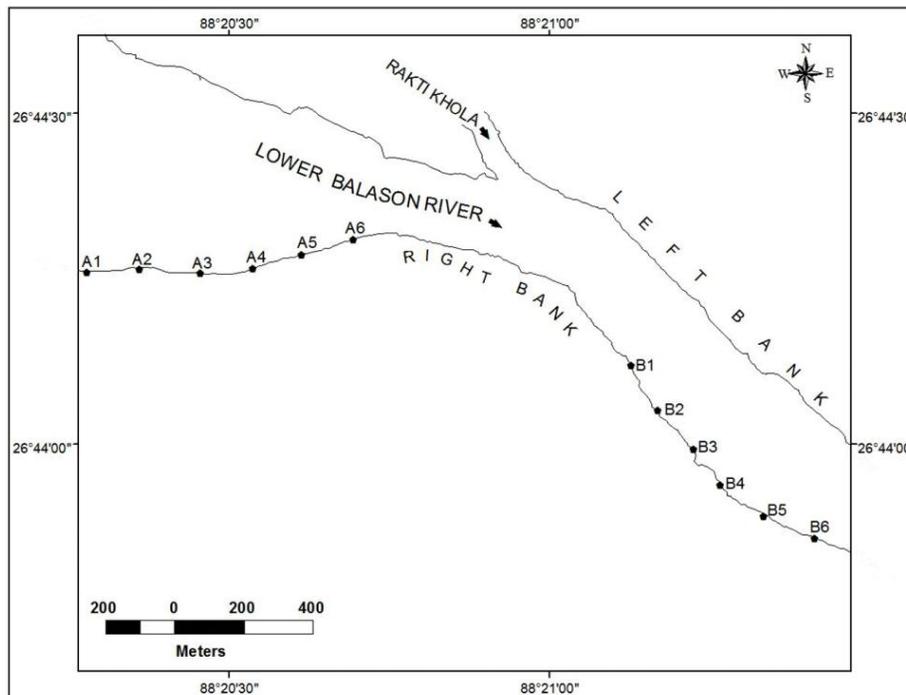
Figure 3: Location of the stretch and points considered for measuring the bank failure rates

the bank base resulting under cutting, the bank failure was higher with maximum of 1.480 measured during 2010 at A5 and 1.335 m measured at B2 during 2008. The nearness of human settlements and roads has also affected the bank conditions and annual retreat of bank has been noticed (A3, A4 and A5).

Moreover, near-bank extraction of bed materials has resulted in diversion of channel towards the bank during high discharge thus increasing the bank undercutting and consequent failure in stretch B (B2 and B3). But at this stretch it can be noticed that failure has gradually decreased (B4, B5 and B6) due to substantial increase in vegetative cover on bank top.

On the basis of the bank top distance measurements, it can be said that along the stretches surveyed on right bank of the lower Balason river, the banks are eroding at an average rate of 0.615 m for stretch A and 0.319 m at stretch B and at 0.467 m for the entire stretch of 2 km (table 2). The variation of failure rate in this two stretches is largely due to the bank composition, the extent of under cutting and the extraction of bed materials.

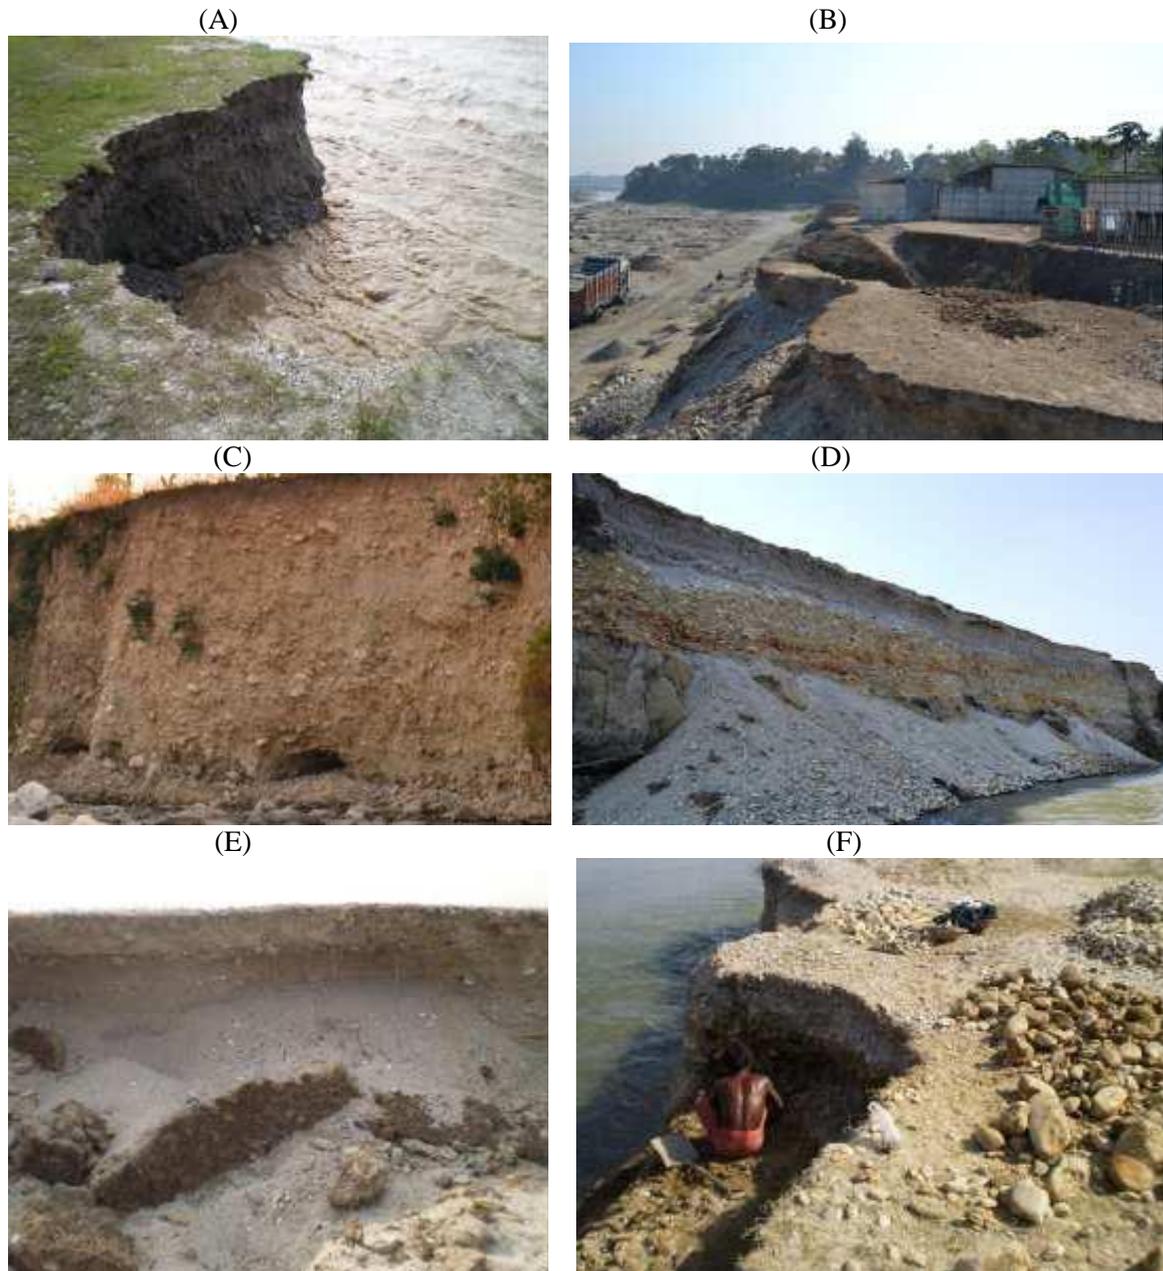
The construction of houses and roads near banks has further aggravated the failure of exposed banks as the extractors prefer to settle near the banks for easy access to river bed (plate 1B). The accumulation of extracted bed materials over banks during monsoon high flows when entering into river bed is not possible. Such overweight undercuts the banks. The human settlements have also reduced the vegetative growth over banks which lead to collapse of bank materials during monsoon downpour (Tamang and Mandal, 2010). The construction of roads near banks for transporting extracted materials and entry paths used by extractors for entering into the river has also reduced the bank shear strength creating vibrations due to continuous running of heavy trucks laden with extracted bed materials. In few places it has been noticed that the bank materials are directly extracted from bank base as well as from the bank surface. Such acts along with extensive lowering of river bed due to extensive bed material extraction during non-monsoon periods together have been largely responsible for the existing condition of banks along the lower Balason River.

This type of failure of banks caused due to impinging high velocity channel monsoon flow which results in slumping of bank materials (Shrestha, 2007) have been noticed mostly at concave bends along the upper piedmont segments of the lower Balason River. The banks at such bends are almost at right angle and undercut has formed holes with deposits of upper loose bank materials at the base of the bank (plate 1C).

base. The frequent use of overbank surface due to human occupancies and running of trucks have caused slips of loose materials at the base (plate 1D).

In the lower segment (near the confluence), the banks are composed of loose finer materials with few gravels. Here human settlements within floodplains near embankments and channel flow at bank base have triggered the mass slumping of loose top materials. The top grass covered blocks of banks at bank base can be noticed at many places along this segment of the lower Balason River (plate 1E).

Plate 1: Channel flows during monsoon period undercutting bank base (A), human occupancies near retreating banks in the middle segment (B), the undercutting of banks forming holes at base common in the upper piedmont segment (C), rotational slips accumulating the loose bank materials at the base common in the middle segment (D), slumping of bank tops common in the lower segments (E) and direct extraction of bank materials (F) along the lower Balason river (Photographs by the author).

segments (near the confluence) failure have been noticed on the left bank. This has been largely due to frequent diversion of channel flows depending on the monsoon peak flows causing scouring and under cutting at bank base, the extent of human occupancies and extraction of bed materials (plate 1F) which are largely triggering the rate of bank failure. The failure of exposed banks are acting as local sediment sources for the river and due to continuous bank failure at few stretches, the finer sediments are being carried away by the river during monsoon flows. Such suspended loads are being deposited in the lower segments causing siltation near its confluence.
