## **WATER LOGGING HAZARD AT NORTHERN PART OF PADMA BRIDGE ADJACENT AREA**

**Md. Ashraf Hossain and \*Hossain Mohammad Arifeen**

*Geological Survey of Bangladesh, 153, Pioneer Road, Segunbagicha, Dhaka-1000*

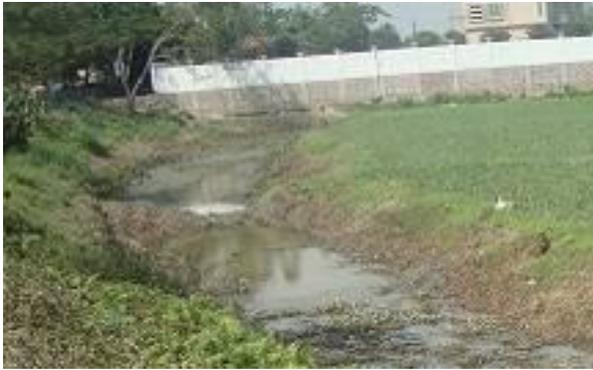
**Plate 1: Private Construction at Khidirpara, Lohajang**

I) *Unplanned Construction*: The importance of the area is increasing day by day; especially the Padma Bridge makes the area worthy in economic aspect to the people. In recent years, People have been fast erecting their residential buildings on agriculture lands in the district since the multipurpose bridge was proposed over the Padma river. The residence of that area are constructing very whimsically without considering the trend or attitude of the channel or wet lands (Plate-1). Hence, unplanned residency is blamed for water logging in the district (Dhaka Tribune-15.11.2014). They also construct various shops or trade centre for their professional needs. Different government agencies also built multipurpose structures which are responsible for water logging. Rehabilitation centre for land loser due to Padma Bridge are one of the reasons of water logging (Plate-2). People are constructing roads on the low land for communication purposes that hampering water flow path and this causes water logged like pocket.

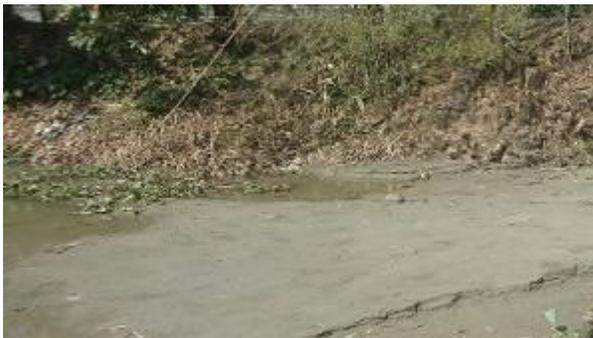
**Plate 3: Unplanned Sand Filling at Holdia, Lohajang**

II) *Unplanned Sand Filling*: The people of the area increasing day by day and at the same time the land which is suitable for making house or other structures is decreasing. So, they need new land to build infrastructure. In that case the low land is filled by river sand in very unplanned way and ultimately the surrounding area undergoes water logging problem (Plate-3 and 4).

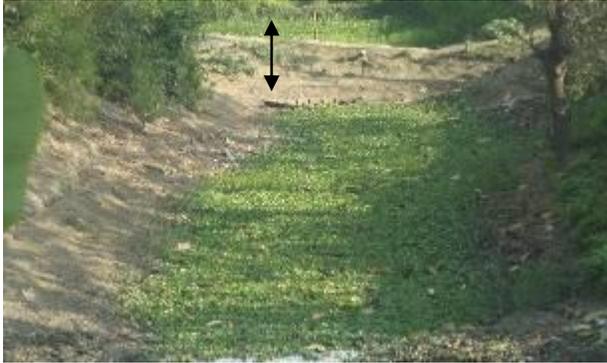
III) *Embankment and Micro Dam*: In some cases, people change the channel courses or interrupt the water flow by making micro-dams on their flow-paths (Plate-5). This is another reason of water logging. Again, Embankments are frequently constructed on both the banks of water body or channel to protect the area from flood or to construct roads (Plate-6). In general, these embankments increase siltation on the

**Plate 5: Micro Dam for Walkway at Singpara, Sreenagar**      **Plate 6: Embankment at Bejgaon, Lohajang**

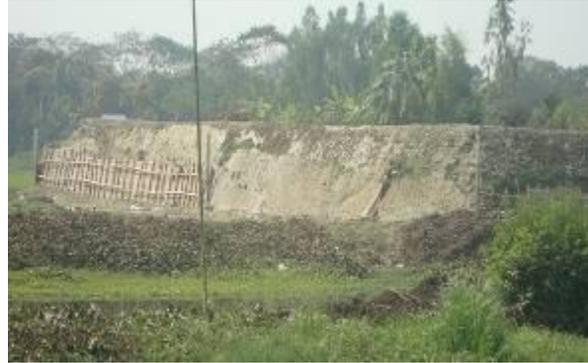
river bed which causes drainage congestion. In the field visit, it is found that embankment without required drainage line (water passing line) is also responsible for water logging. During rainy season, heavy rainfall is seen and excessive rain water cannot drain out properly. This is one of the reasons for water logging of the area.

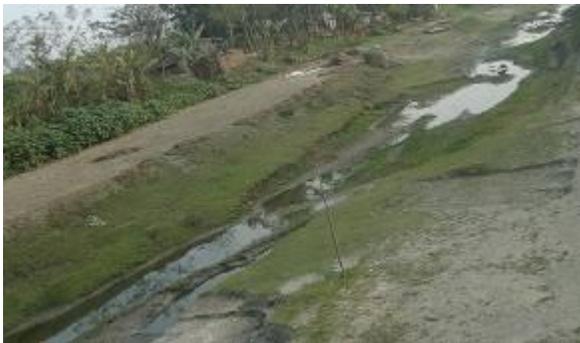
IV. *Siltation*: Siltation in natural drainage system is another problem of water logging. During flood time, the mighty river and other rivers and channels are over flooded and deposited sediment in the lowlands, water bodies and channels that disrupt the water flow (Plate-7 and 8). Again, rain water carry out different construction materials like bricks, sands, and stones; leaves; household wastes; street sweepings etc. therefore, increased impervious surface of storm water drainage and created favourable condition for water logging by reducing the runoff capacity of the drainage system. Five canals including Baligaon-Ghordaur canal, Atigaon-Morshodgaon canal, Puraganga canal, Manda-Sreenagar canal and Dakhin Halodia-Goali have been filled up with sand. People said the canals linked to agriculture lands have been filled up with sands or silt and so water cannot be removed from agriculture lands (The Daily Observer-20.11.2014) and reduced the carrying capacity.

**Plate-7: Siltation at Goalimandrakhal, Patavog, Sreenagar**      **Plate-8: Siltation at Baligaon khal, Khidirpara, Lohajang**
