## **TRACE METAL INDICES IN THE CHARACTERIZATION OF HYDROGEOCHEMICAL CONDITION OF SURFACE WATER ALONG ASA RIVER, ILORIN, KWARA STATE, NIGERIA**

The effects of industrial, agriculture and domestic discharges on the quality of water along ASA River located in Ilorin were investigated using trace metals in April 2012 when the water level along ASA River was low. The choice of sample locations was based on the land use pattern along the ASA River with a view to determine the impact of such activities on the various levels of metal pollution. Seven locations along the river bank were selected particularly areas that receives effluents into the river. The results of trace metals such Cd, Cr, Mn, Ni, Fe, Co, Cu, Pb and Zn in surface water along ASA River reveal a general high contamination when compared with World Health Organization (WHO) and Federal Environmental Protection Agency (FEPA) standards and the source of these pollutants could be diverse ranging from industrial to agricultural and domestic sources. Regular monitoring of surface water of ASA River should be carried out as there is notable increase in the level of human and industrial activities along the course of the river.

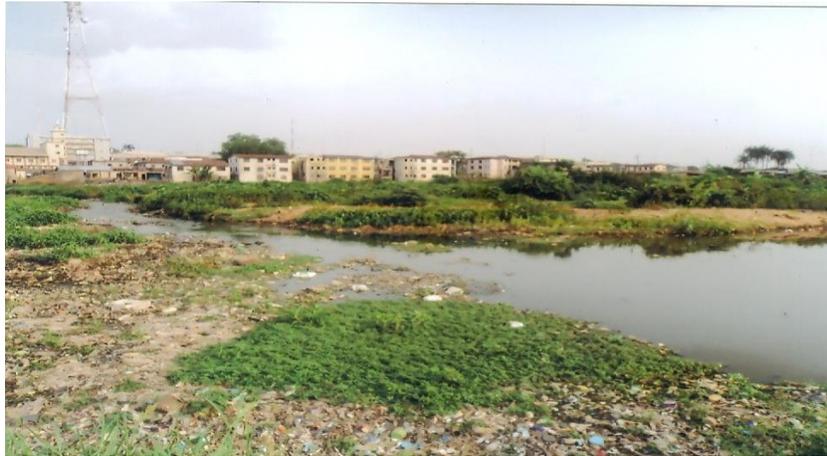
**Figure1: Heap of refuse dumped at the Bank of ASA River in Amilegbe Bridge, Ilorin.**

ASA River originate from Oyo state and flows through Ilorin in a South-North direction forming a dividing boundary between Eastern and Western Ilorin. The ASA River flowing almost South- North divides the city of Ilorin almost to two equal halves (Figure1). The river and its banks have been turned in

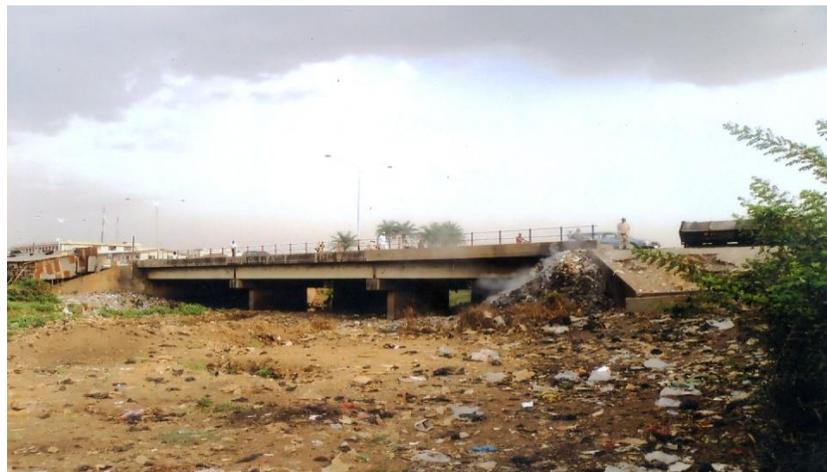
**Figure 2: Refuse dumpsite, under the Bridge at Railway station, Ilorin.**

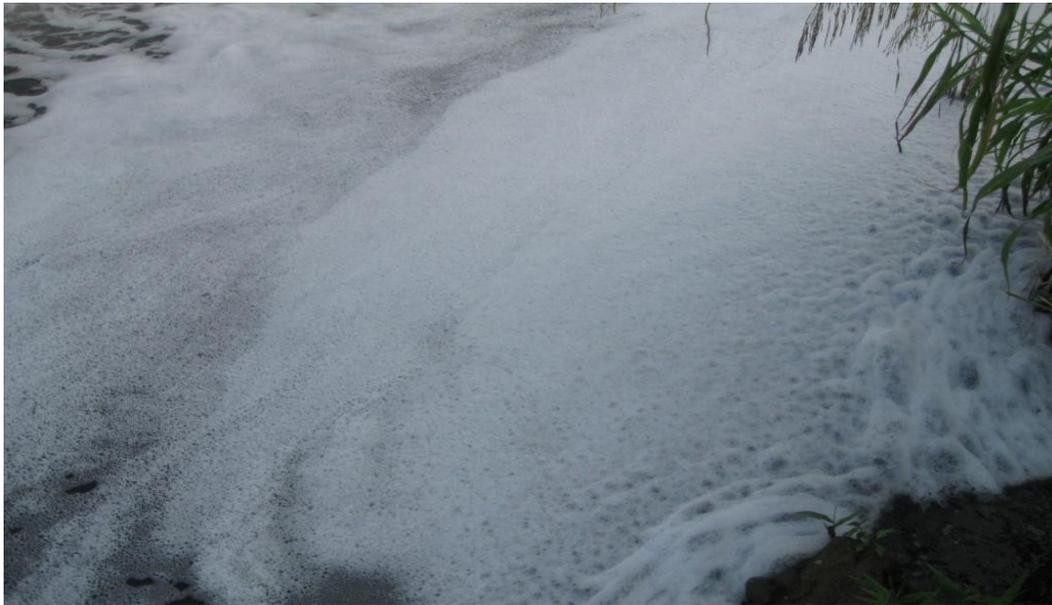
**Figure 3: Effluent of Soap and Detergent Industries at ASA Dam.**
