Review Article

A COMPREHENSIVE REVIEW ON PAGLAJHORA SINKING ZONE LANDSLIDE IN THE SHIVKHOLA WATERSHED OF DARJILING HIMALAYA

***Sujit Mandal**

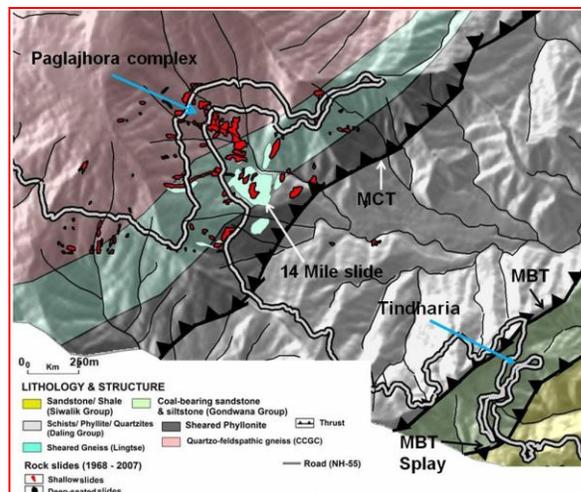
Figure 2: Paglajhora sinking zone with lithology and structure (Ghosh *et al.*, GSI)

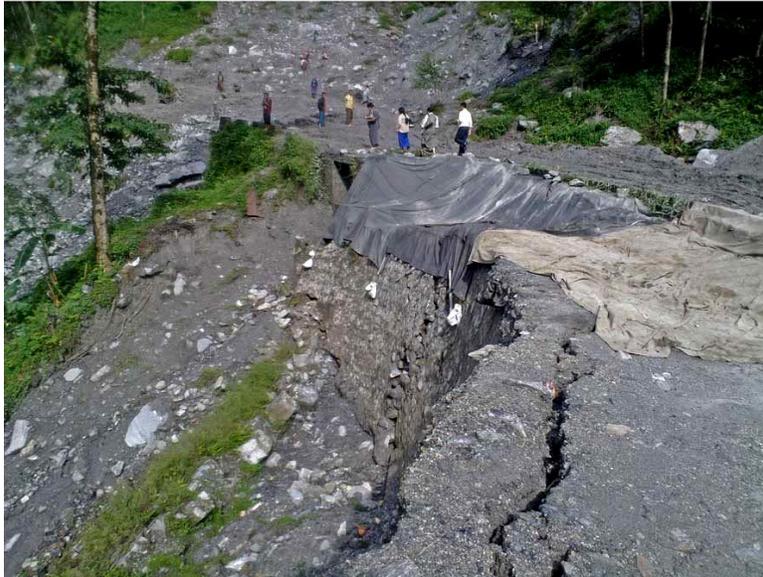
Figure 4: Gradual subsidence of the outer edge of the Hill Cart Road at Lower Paglajhora, 2010

- The National Highway 55 (Siliguri-Darjeeling Highway) has suffered repeated failures for decades in the Pagalajhora sector and remained a major eyesore as far as traffic movement is concerned. The area exposes the highly tectonised sheared gneissic rocks close to Main Central Thrust (MCT) (Figure 2) belonging to the Darjeeling and Daling Groups, which are separated with each other by the Main Central Thrust (MCT). In the 14 Mile slide, a 500 m reach of the Highway has remained breached, thereby totally disrupting the movement along the road and Heritage Rail Route since 16 June 2010 and impacting the socio-economic activity in the hill region in very significant way (Figure 4).

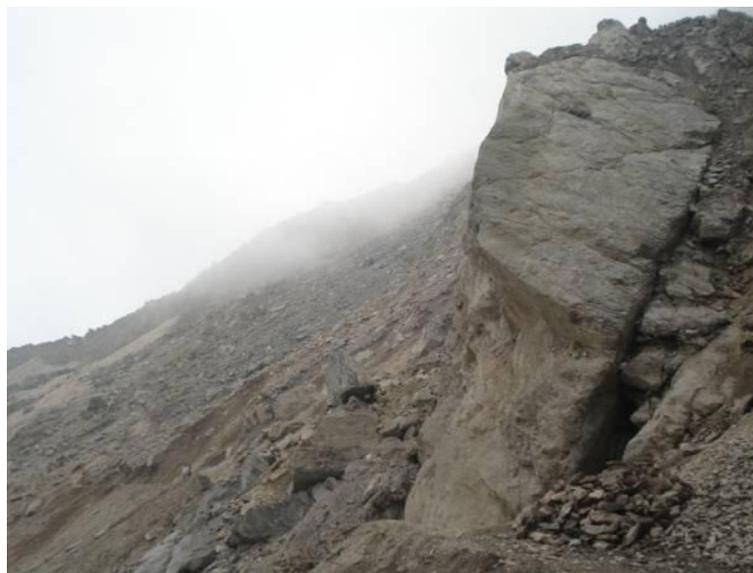
Figure 5: Dislodgement of the debris and rocks block after September, 2011 Earthquake at Paglajhora

slopes by shotcrete. However, consequent to the 18 September 2011 earthquake, a huge rock block having rough dimensions of 15m×10m×8m slipped along steeply dipping joints, thereby blocking the restored reach once again (Figure 5).

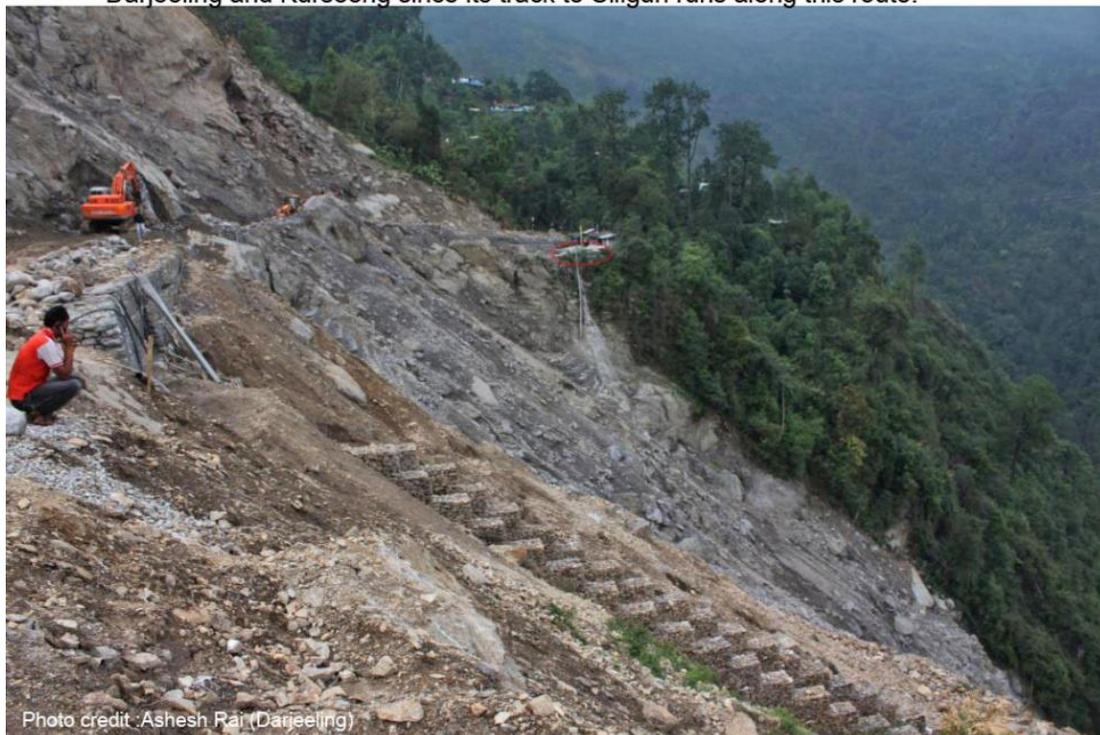
Figure 6: Lower Paglajhora (14 Mile landslide) on NH 55, May 2011

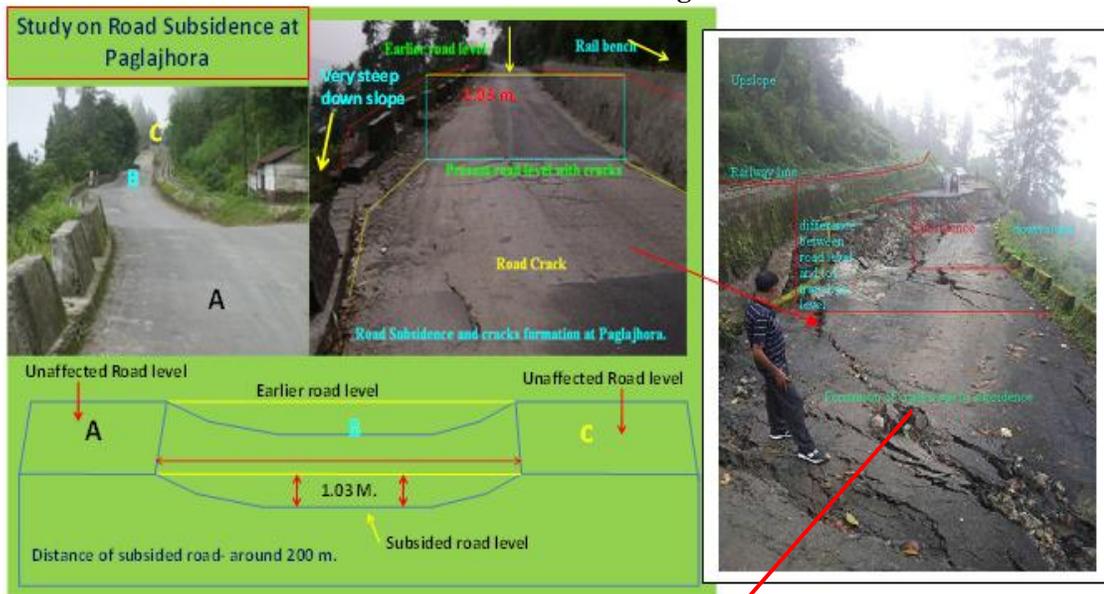
Figure 13: Road subsidence at Lower Paglajhora (2009)

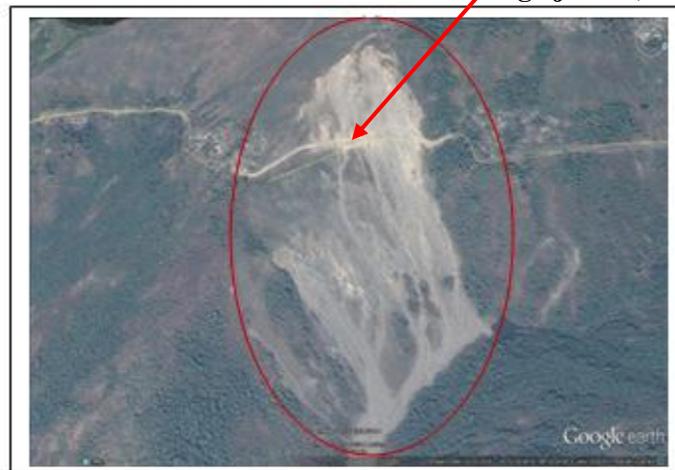
Figure 15: The destruction of the Hill Cart Road at Lower Paglajhora in June, 2015

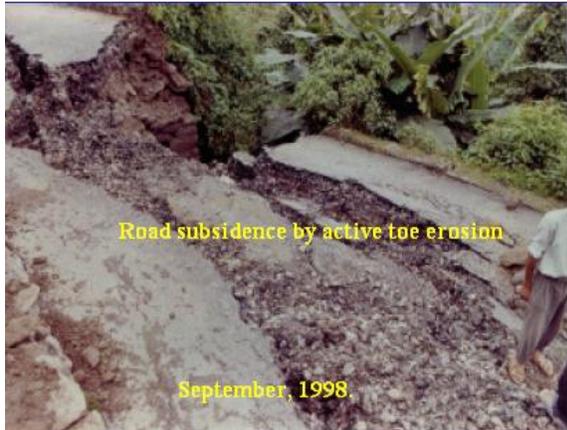
Figure 16: Damaged NH-55 at Paglajhora

Near Pagla Jhora a distance for about 2 km. road tract acutely suffers from severe subsidence (Figure 16). Randomly oriented surface run-off triggers active headward and toe erosion within this loose unconsolidated landmass (Figure 19). Maximum erosion is being done by underground seepage water that causes tremendous piping action by removing fine particles giving rise to continuous creep and subsidence of slopes (Figure 18).

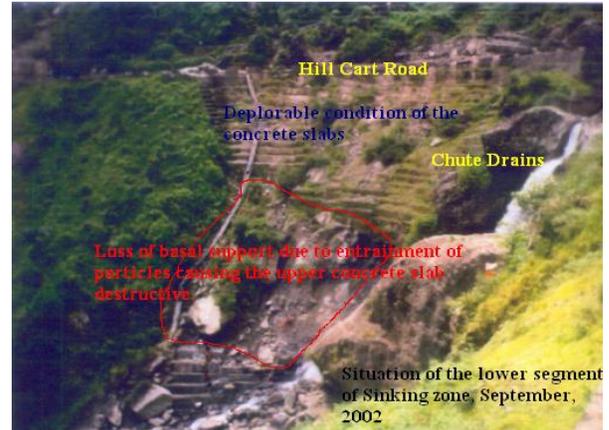
Figure 17: Deplorable situation at the base of Hill Cart Road

Shearing stress of the deformed and less cohesive steep slope surface material is higher than the shearing resistance because these types of materials are affected by over saturation and more hydrostatic pressure and thus the materials subside gradually (Figure 11 & 12). The N.H.55 road cum rail bench trails at two different levels within the Paglajhora Sinking Zone for a total length of almost 2.5 km. (Figure 13). The N.H.55 within this stretch has suffered heavy sinking (6-8 meters even) and continuous distress with ages. At Paglajhora to preserve the deep sliding masses high retaining walls have been erected to resist downward movement of slope materials. But such constructions are putting an immense pressure on slope day by day (Figure 17).

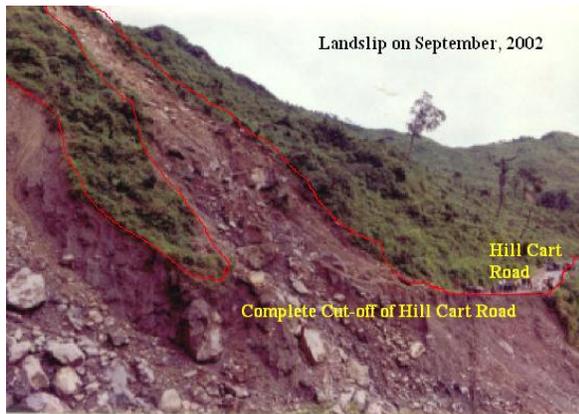
Figure 18: Removal of debris from steep upslope at Paglajhora

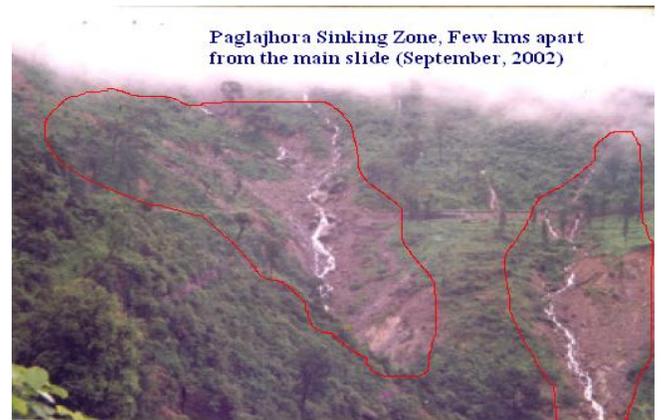
Figure 19: Initiation of drainage and slope failure

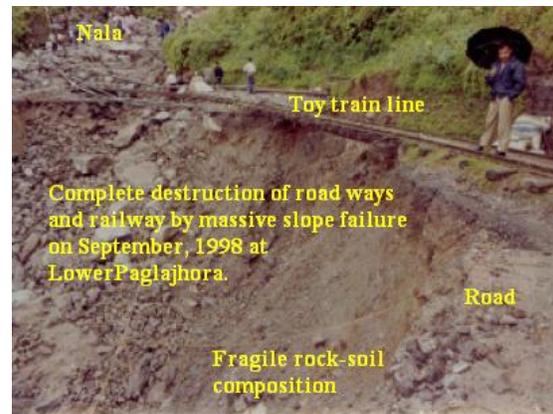
Figure 21: Elimination of road and railway line

sides of the River Shivkola and the extent along the road will be approximately 500 m. Just above the road the slope is around 65° . The downhill slope is around 70° . Others physical properties of soil also exhibit the slope surface is more vulnerable to failure (Figure 21). The area is influenced by number of nalas along which the seepage is a quite common phenomenon. The slide is reported to occur mainly during the monsoon when the area receives heavy precipitation. A road Subsidence took place in July, 2009 during continuous heavy rainfall and destroyed around 35 m. road on the right bank of the Shivkhola. The cumulative effects of the joints have made the rock fissile which in conjunction with its soft nature has become incompetent and prone to easy erosion and slope failure. The area contains very fragile and thick accumulation of decomposed materials with micaceous soil components having no less cohesion and plasticity. There is very easy seeping and percolation of water through non-cohesive materials in the sinking zone at Lower Paglajhora (up slope & down slope) which has caused a massive destruction (Figure 21).

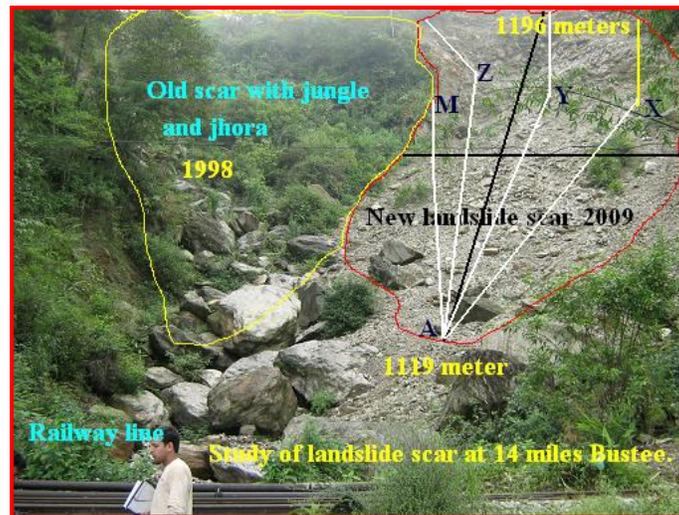
Figure 22: Study of landslide at 14 Mile Bustee (2007)

A study was conducted on 14 mile bustee landslide in 2007 after the occurrences of fresh landslide along the Hill CART Road (Figure 22). Study showed that 14 mile bustee landslide is located at the distance of 37.25 km from Siliguri where the elevation is 1118 meter. The average length of the slide is 90 meter and average width is 25 meter covering the total area of about 2250 sq.m. The average slope angle of the slide is 59° with less cohesion (0.18) and friction angle ($17^{\circ} 30'$). The calculated safety factor on the basis of geo-technical parameters of soil is 0.96266 (Mandal and Maiti, 2012). The collected soil sample from different location of the sinking zone revealed that the low cohesion, low friction angle and high wet soil density of the soil leads to gradual and continuous subsidence of slope materials at Paglajhora (Table 2).

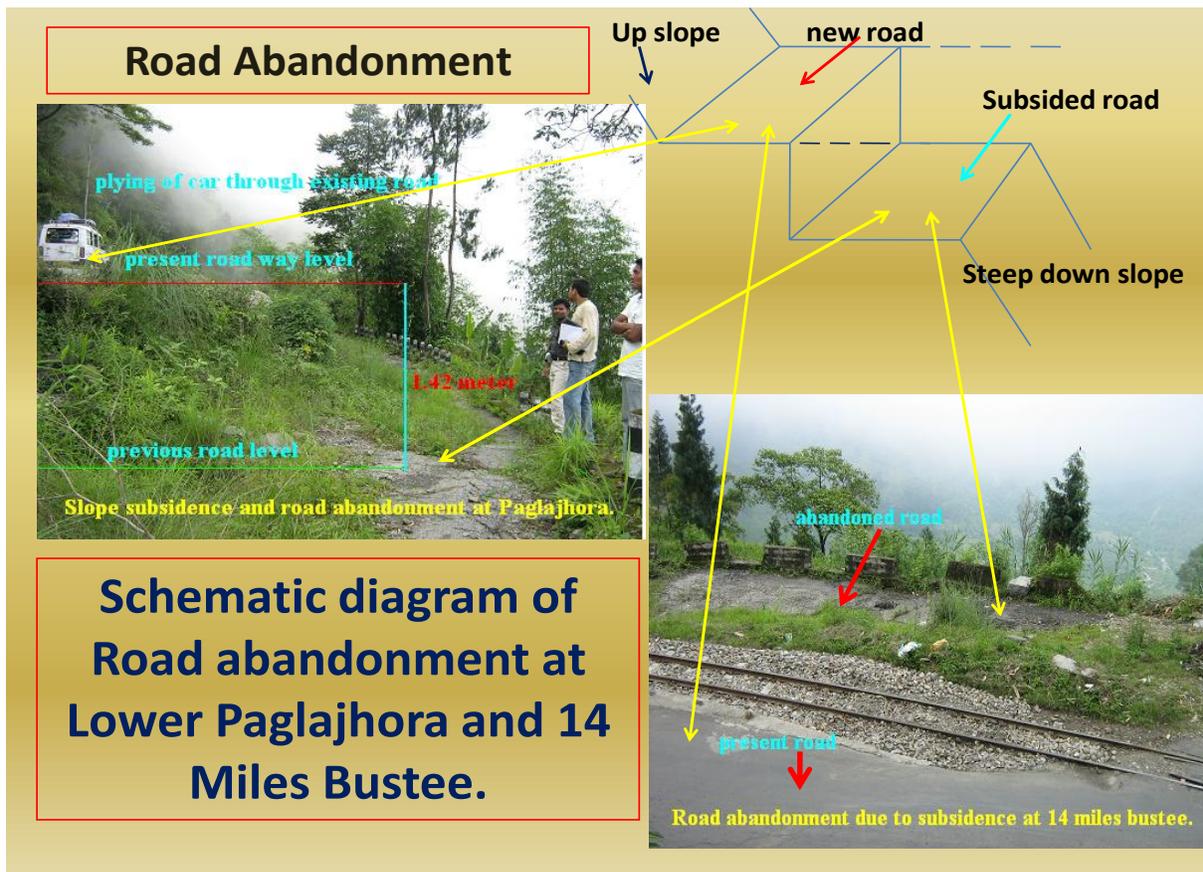
Figure 23: Road abandonment in Paglajhora and 14 Mile Bustee

facing slope with fragile lithological composition is heavily affected by the down slope movement of slope materials and the subsidence of road and rail-cut benches (Figure 23).

- Length of subsided road: 125 meter.
- Amount of subsidence: 1.42 meter.
- Gradient of the slope: $> 70^{\circ}$; wet density:-2.14 and dry density: -1.86.
- Lithology: Highly foliated gneiss & mica-schist; Cohesion-0.12; friction angle- $22^{\circ}30'$.
- Causes of subsidence: loss of basal support of the slope by active down cutting of the Shivkhola, easy saturation of unconsolidated slope material through seepage, steepening of slope by road cutting and plying of loaded vehicles and related vibration.

- Location: 37.5 km from Siliguri (Elevation-1130m).
- Date of the survey: September' 2008.
- Length of subsided road: 68 meter.
- Amount of subsidence: 0.95 meter/year.
- Gradient of the slope: $> 65^{\circ}$ (down slope of the subsided road); friction angle- 19° .
- Lithology: Highly foliated gneiss & mica-schist; cohesion- 0.25; wet soil density:-2.08 and dry soil density: - 1.79.

Since 2010, the abandoned roads as well as unaffected road are being affected by consecutive destructive landslip events of 2011, 2012, 2014 and 2015 (Figure 23). The reactivation of the landslide events at Paglajhora sinking zone has brought a tremendous threat to the local people. Such reactivation of landslide phenomena at the sinking zone is the result of drainage concentration over the fragile lithology and soil.
