Case Report

IS MRI A SAFE DIAGNOSTIC TOOL? A CASE REPORT

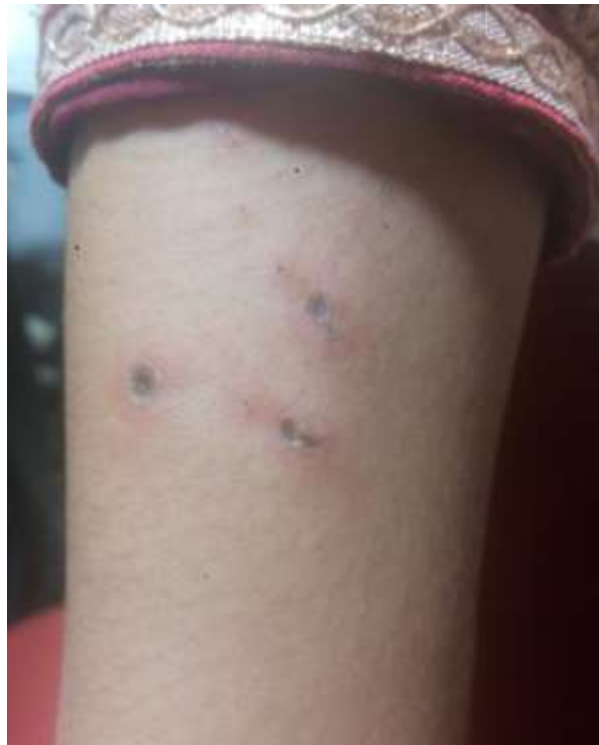
We were confronted with a case, a 23 years old female patient, a bit obese in habitus, came for MRI of back. She encountered superficial burns in her forearm, arm and neck while acquisition in 1.5 T MR scanner. No any history of application of the cosmetics or tattoos has been found in this case. Patient started feeling heating sensation after 5 min in the MR scanner followed by burning sensation in these sites and resulted in multiple blisters formation seen after the examination (fig.1). These blisters healed with a residual scar on follow up (images not available as patient from remote area).

Figure 1. Showing minor burns in arm on MRI

Since MRI burns are more common on 3T MRI. But in this unusual case we encountered frank blisters while MR acquisition in 1.5 T scanner. No faults had been found in the scanner at that particular time. The possible risk factor for burns in this case could be the material in clothes (undergarments or deposited from embroidered shirt) she used at that particular time as we ruled out other factors. To the best of our knowledge this is the second reported case of MR imaging related burns associated with clothing (Pietryga *et al.*, 2013). The teaching point from this reported case is that MRI burns is among avoidable risks and the importance of changing to safe garments even the undergarments is important before MR imaging.

Though MRI is a safe, routinely used diagnostic tool, MR imaging related burns are among the avoidable risks and the importance of changing to safe garments even the undergarments is important before MR imaging.
