SEISMIC PERFORMANCE OF RC FRAME STILT BUILDINGS – A REVIEW

Arabinda Sharma and *Neeraj

Department of Civil Engineering, BRCM-CET, Bahal, Bhiwani

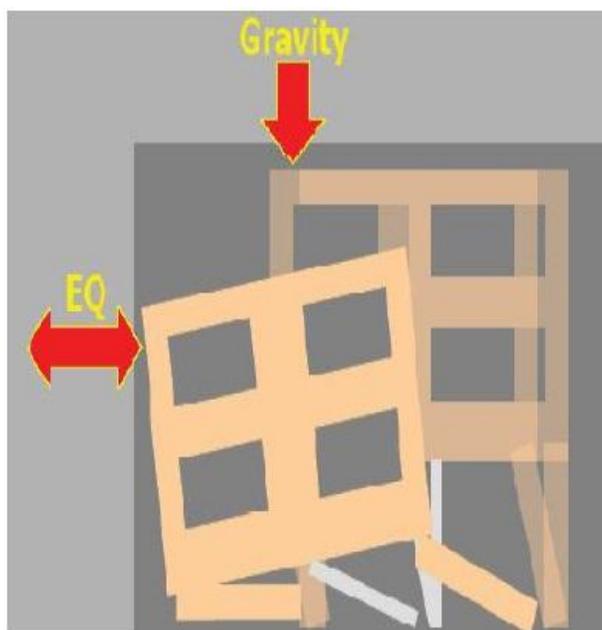
Figure 1: Collapse Mechanism of Structure Having Soft Storey (Setia *et al.*, 2012)

formed due to the high level of load deformation (P- Δ) effects. Figure1 shows the collapse mechanism of a stilt building structure under both seismic and gravity loads (Setia *et al.*, 2012).

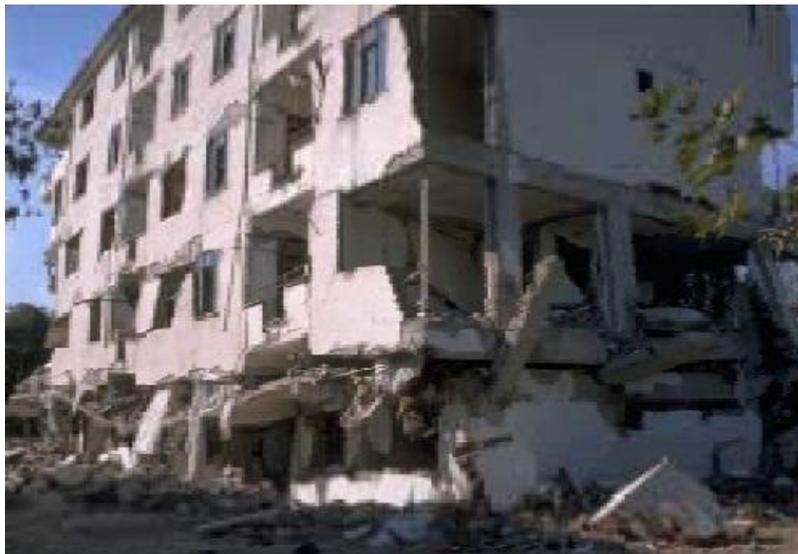
Figure 2: Soft Storey Mechanism Formed after the Fall Out of Infill in the Bottom Two Storeys (Dolsek *et al.*, 2001)

In the 1999 Kocaeli (Turkey) Earthquake, a large number of multi-storey RC framed buildings with masonry infills collapsed. Typically, a storey mechanism was formed in the bottom storey or in the bottom storey or in the bottom two storeys. In some cases, the obvious reason was soft storey effect due to absence of infill walls in the bottom storey. In many cases, however, a soft storey mechanism was observed in structures with a uniform vertical distribution of infills after the fall out of the infills in the bottom two storeys (Figure 2). In Figure 3, two similar buildings, located within the same complex of the buildings, are shown after the earthquake. In one building (Figure 3 (a)), which did not collapse, a concentration of damage in the bottom two storeys can be clearly seen. The other building collapsed due to complete failure of the bottom two storeys, as shown in Figure 3 (b) (Dolsek, 2001).

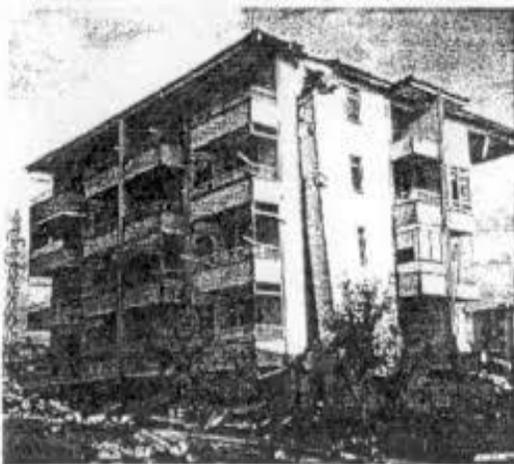
(a) Concentration of Damage in Bottom 2-Storeys

Figure 3: Multi-Storey RC Frame with Masonry Infill near Golcuk (Dolsek *et al.*, 2001)

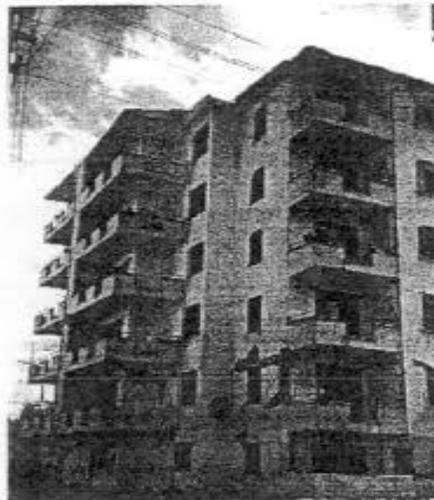
(b) Collapse in Bottom 2-Storeys

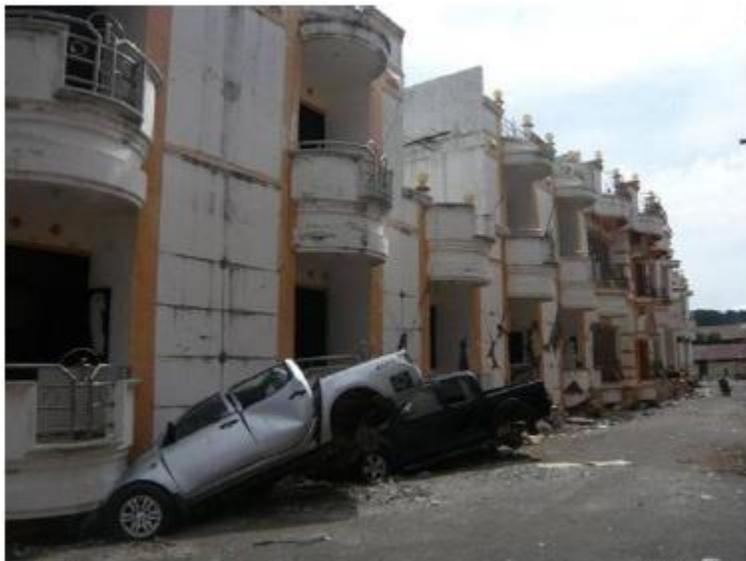
Figure 4: Damage to Soft Storey in Residential Building (Bothara *et al.*, 2010)

the base as they were having an open ground floor and were comparatively stiffer on upper storeys because of infill walls. In other words, the buildings having infill walls evenly distributed horizontally as well as vertically performed well. In certain cases, after the failure of RC columns, the brick walls provided the gravity support system and saved the buildings. In Figure 5 (left) a small building is shown whose front was supported on a retaining wall and the back was on slender stilts. Although this small building survived, it suffered torsion between the wall and building (Figure 5 (right)).

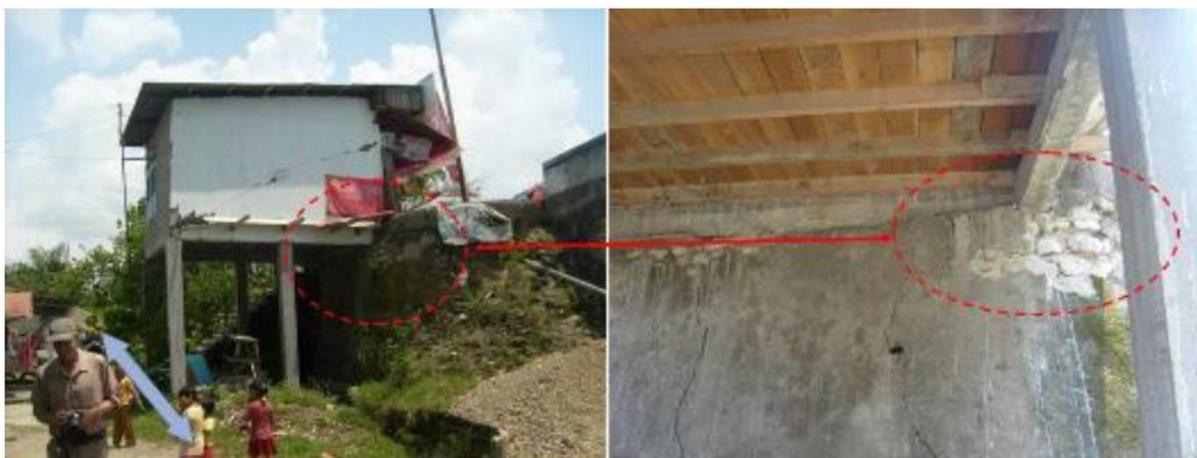
Figure 5: Building on Stilts (Arrow Shows the Direction of Gravity) (Bothara *et al.*, 2010)

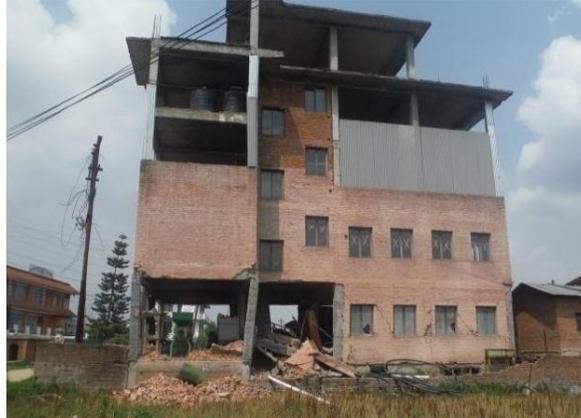
Figure 6: Soft Storey Failure on RC Frame Structure in Kathmandu (Surana *et al.*, 2015)

the ground Storeys when compared with the upper Storeys with more infill walls. The soft ground storey is clearly the primary reason for such damage (Surana *et al.*, 2015).
